# Hunsbury Hill Fort

# West Hunsbury Country Park

Tree Health & Safety Report 2018

**16<sup>th</sup> April 2018**

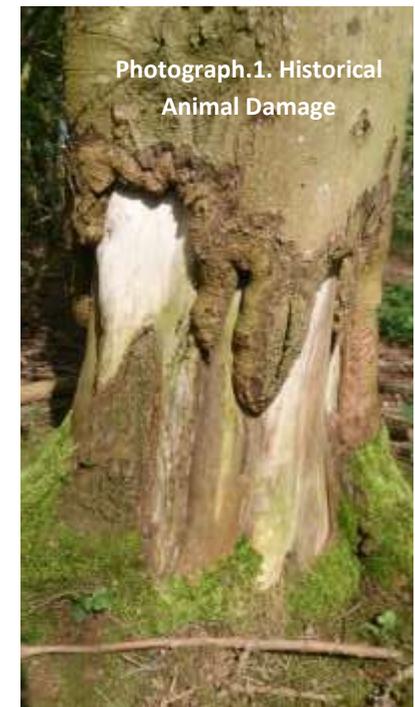
**5.2 Animal Damage:** Historical rabbit and squirrel damage on sycamore and ash is endemic throughout the area. Both species have been decimated in earlier years and are still being damaged by the large population. This causes some of the trees to have misshapen crowns, open cavities at the base and overall weak formation in the tree. There is little that can be done to alleviate the problem and a number of fells throughout the woodland have been recommended. *See photograph. 1.*

Photograph.1. Historical  
Animal Damage

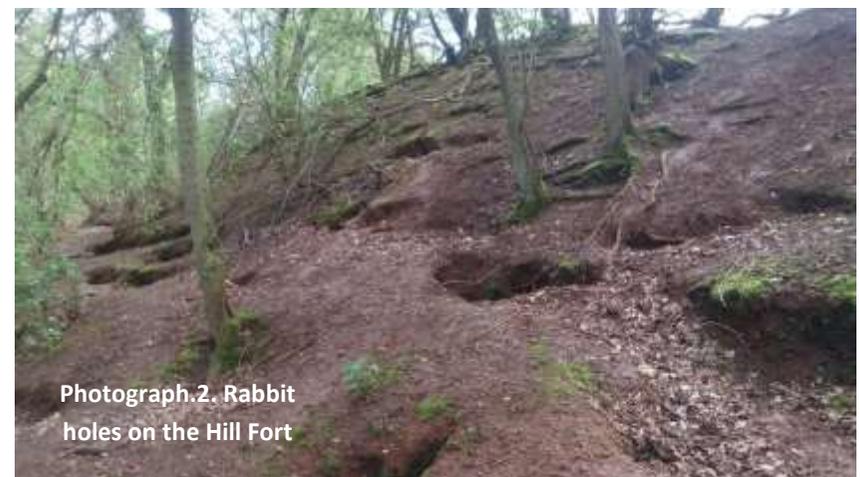
**5.3 The Oaks:** As mentioned in Chapter two, the oaks are a large part of the landscape. These trees must be protected at all costs being the main species to also safeguard the hill fort. There are problems with rabbits undermining the areas between the roots and the ground and there are many examples of exposed roots throughout the ditches and the banks. Although this is also a natural occurrence, the borrowing from the rabbits could weaken the stability of the trees.

Some of the highly populated areas have other excavations around the rabbit holes which indicates rabbiting has taken place at some point in time or foxes in the area have dug for prey. No recommendations can be given apart from a rabbit eradication program, fencing or to remove lower shrubs and trees (not the oaks), fill the holes and grass over. (Impractical because of the scale).

Photograph.2. Rabbit  
holes on the Hill Fort

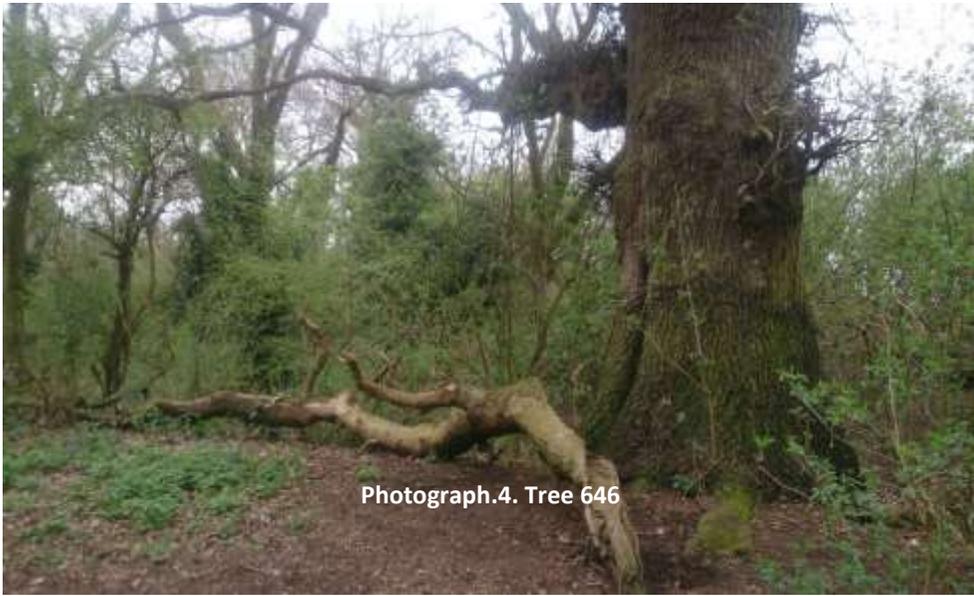
Photograph.4. Tree 646

Tree No.	Species	Age	DBH (cm)	Height (m)	Condition	Recommendations	Notes	Priority
646	Oak	Veteran	142	18	Poor	Remove lower deadwood over path only.	Veteran tree. Important. Approx 200 -250 years old. Hollow at base going through stem to at least 3m. Wire fencing wrapped around base now enveloped into tree. Could remove some of the wire where heavy and able to remove but will leave jagged edges. Long and careful job.	Medium
647	Oak	Over Mature	105	17	Fair	Remove deadwood over path only	Large oak, nice specimen. Previous snapped out limbs. Slight hollowing at rear base.	Medium
648	Cherry	Early Mature	33	15	Poor	Monitor	Large canker at rear. Mallet sounded and decay is not extensive. Still a weak tree but will need monitoring. Behind towards playing field are two sycamore with extensive historic animal damage. Both checked but will need monitoring.	Low
649	Oak	Mature	68	17	Poor	Monitor	A number of woodpecker holes throughout the main stem indicating hollowing and decay. Crown is reduced over path.	Low

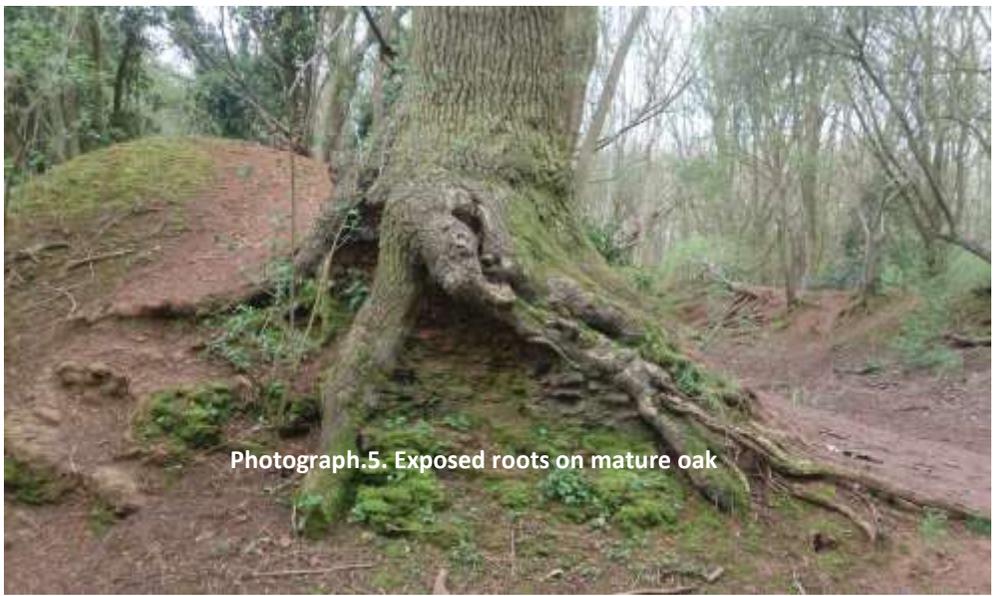
Photograph.5. Exposed roots on mature oak
